File No.s: 10/6232 f 179
Supplier Name: TOYOTA
Received date: 02-Aug-10
Imported? ☐
APRUP? ☐
Officer Initials: _____
Manufacturer.: Toyota A/ market
Make/Model: Seat
Recall File#: _____
Defect: Came loose in crash
Invest. Code: seat
Veh. Code: light goods vehicle
Received Date: 02-Aug-10
Received From: _____
Manufacture Start: _____
End : _____

File No.s: 13/1944**Supplier Name:** TOYOTA**Received date:** 03-Mar-13**Imported?** ☐**APRUP?** ☐**Officer Initials:** s. 22(1)(a)(ii)**Manufacturer.:** TOYOTA**Make/Model:** PRADO**Recall File#:****Defect:** MOONROOF EXPLODED**Invest. Code:** *** Unknown *****Veh. Code:** off-road pass car**Received Date:** 03-Mar-13**Received From:** s. 22(1)(a)(ii)**Manufacture Start:****End :**

Problem or defect: TOYOTA PRADO SUNROOF/MOONROOF DEFECT

RE: TOYOTA PRADO SUNROOF/MOONROOF DEFECT

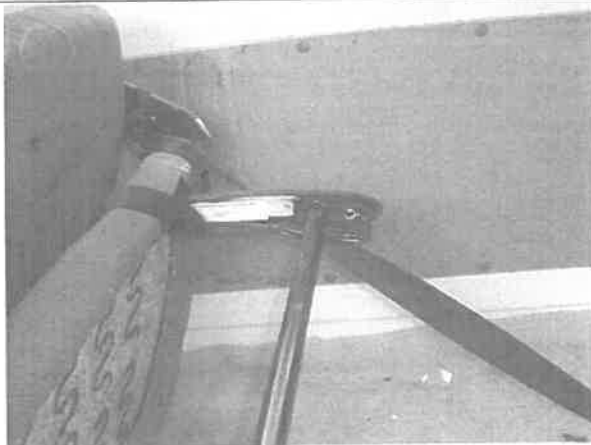
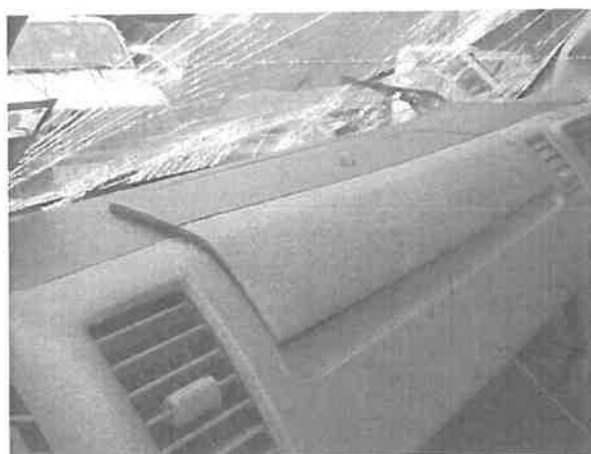
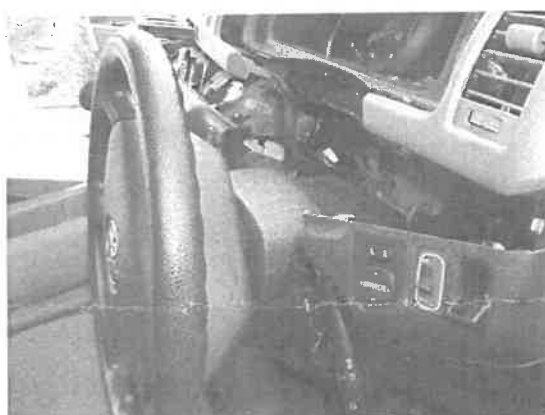
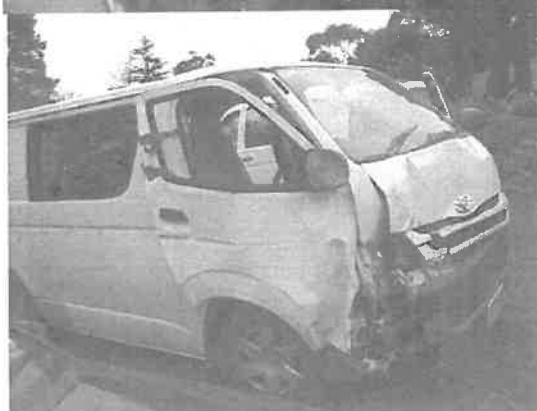
- 1) Why the rear seat detached and flew forward upon impact
- 2) Why neither air bag deployed upon impact.

Included in this letter are photos of the rear seat and the mechanism for securing it; the dashboard to show that the airbags never deployed; the exterior of the car to show the impact. Also, below you will see the ANCAP assessment.

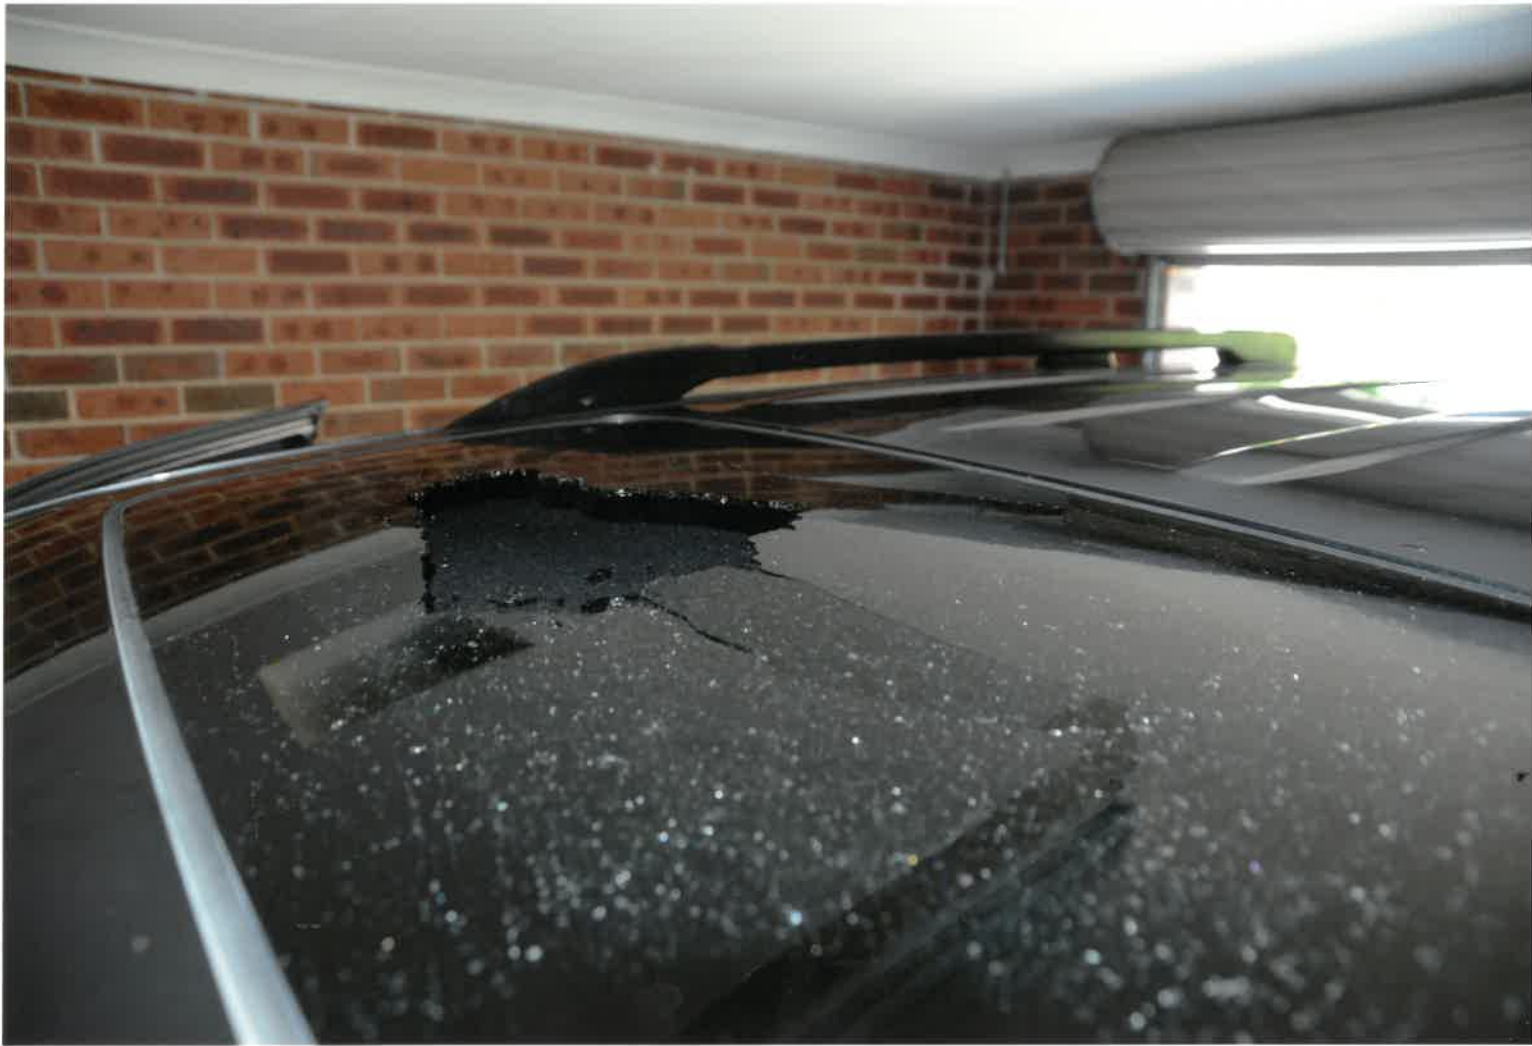
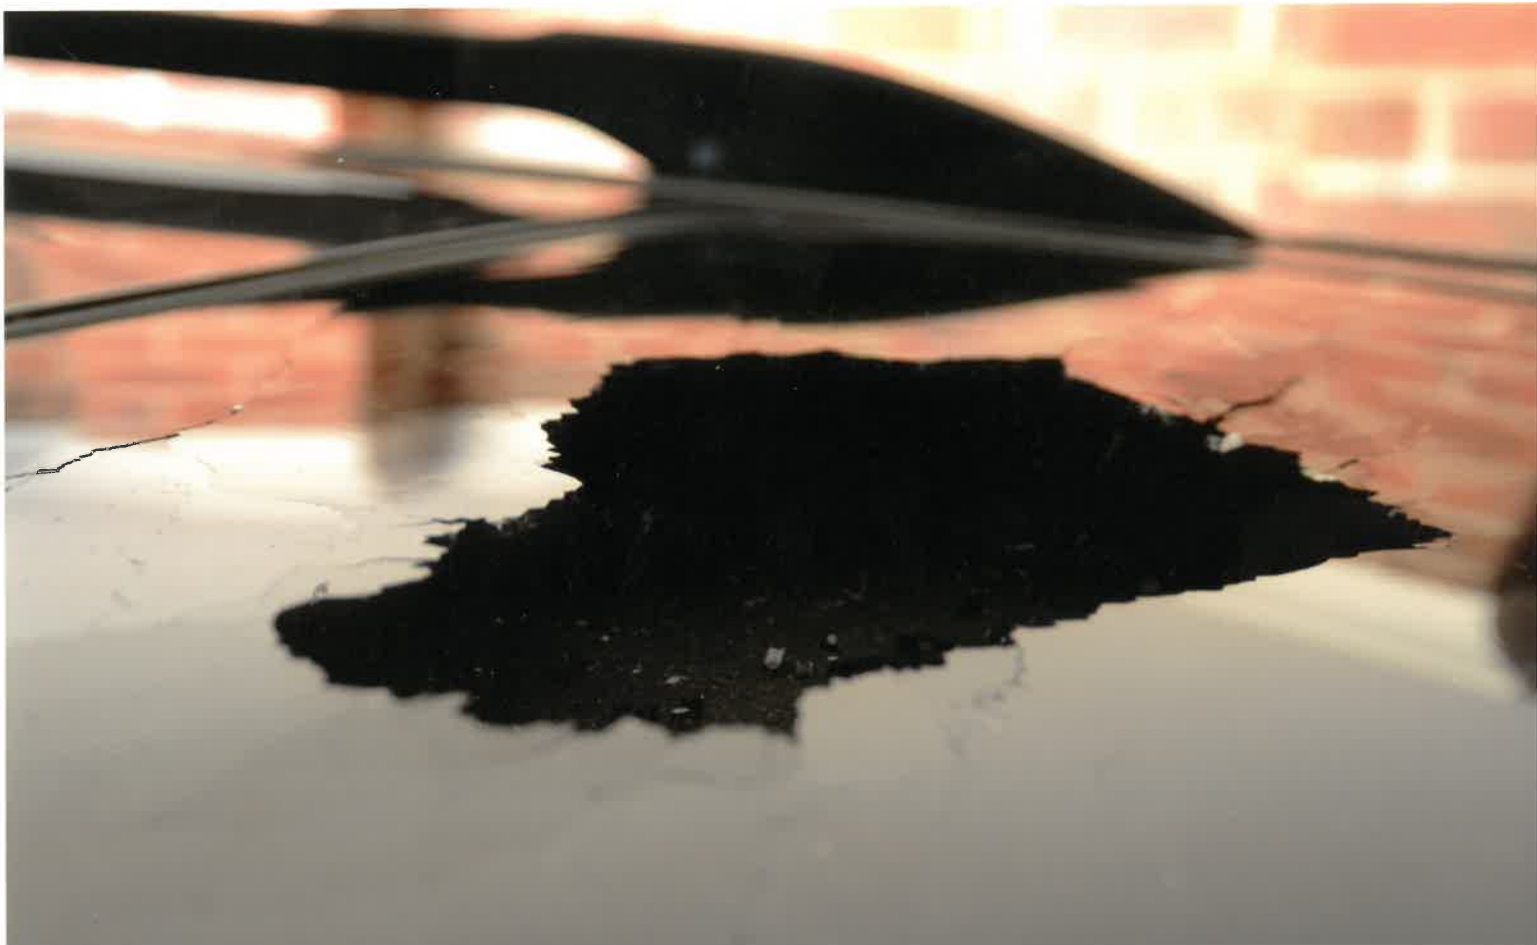
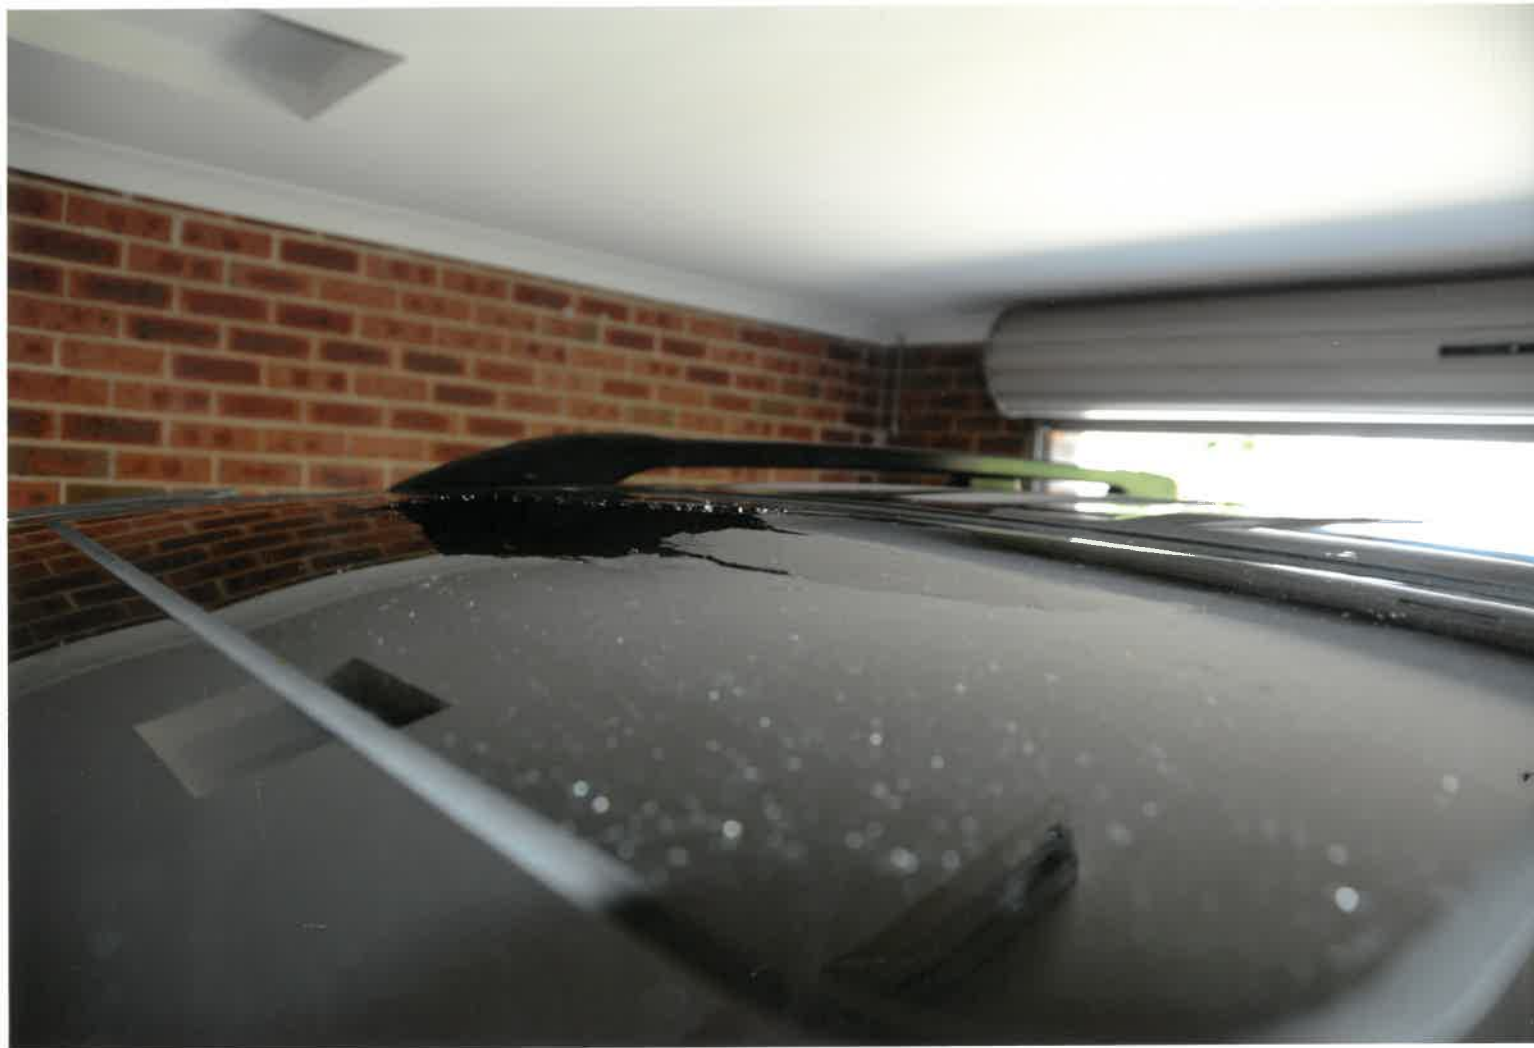
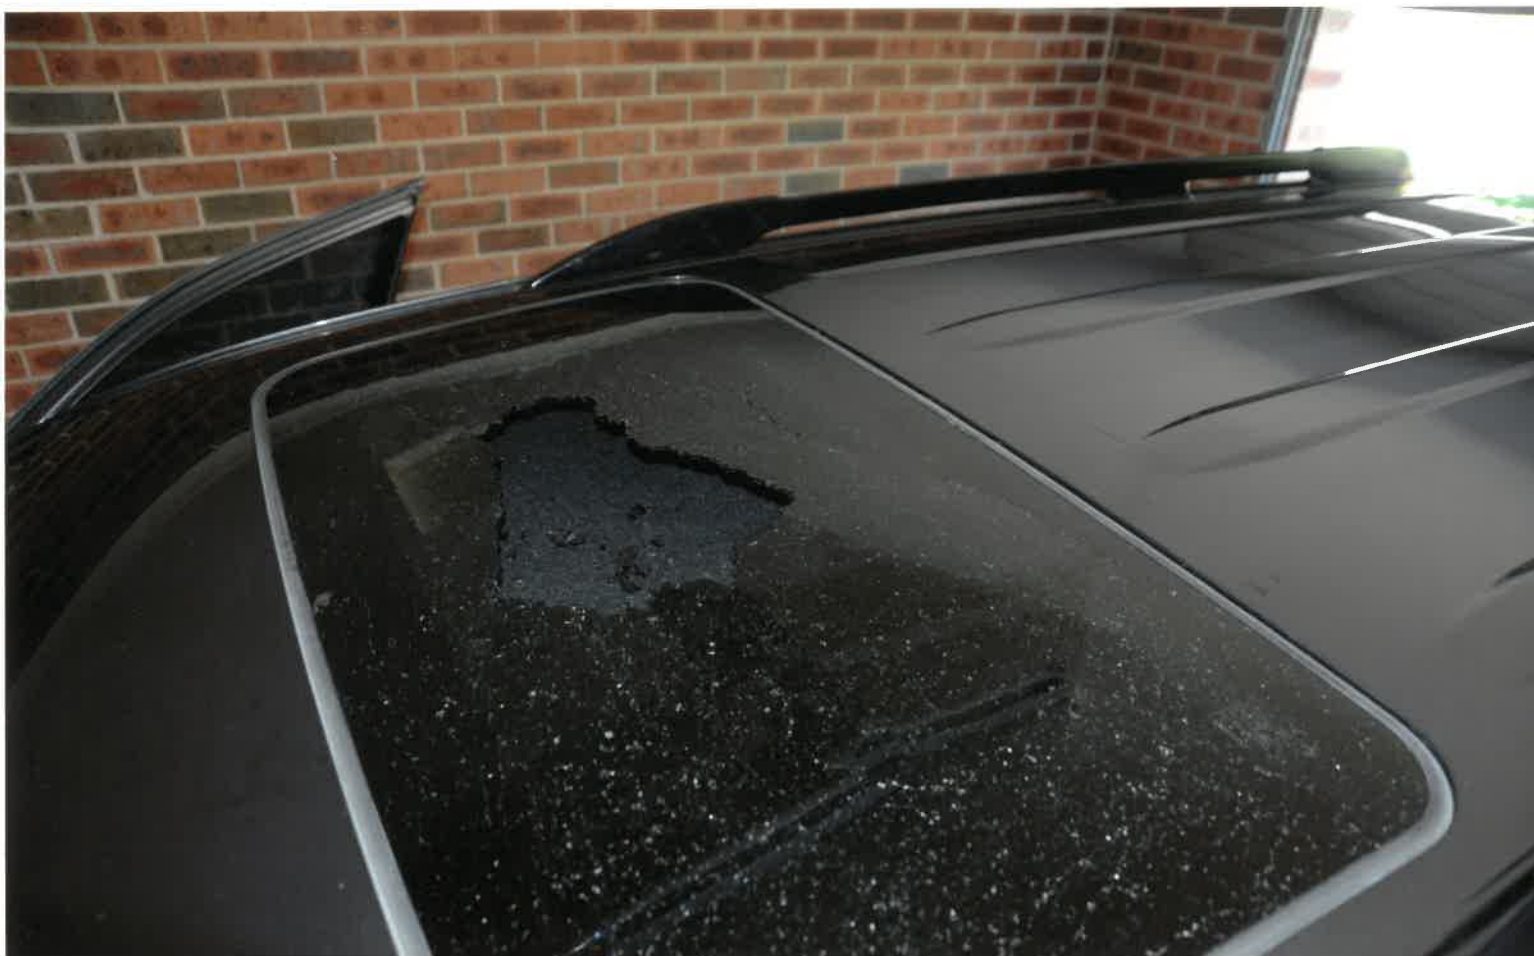
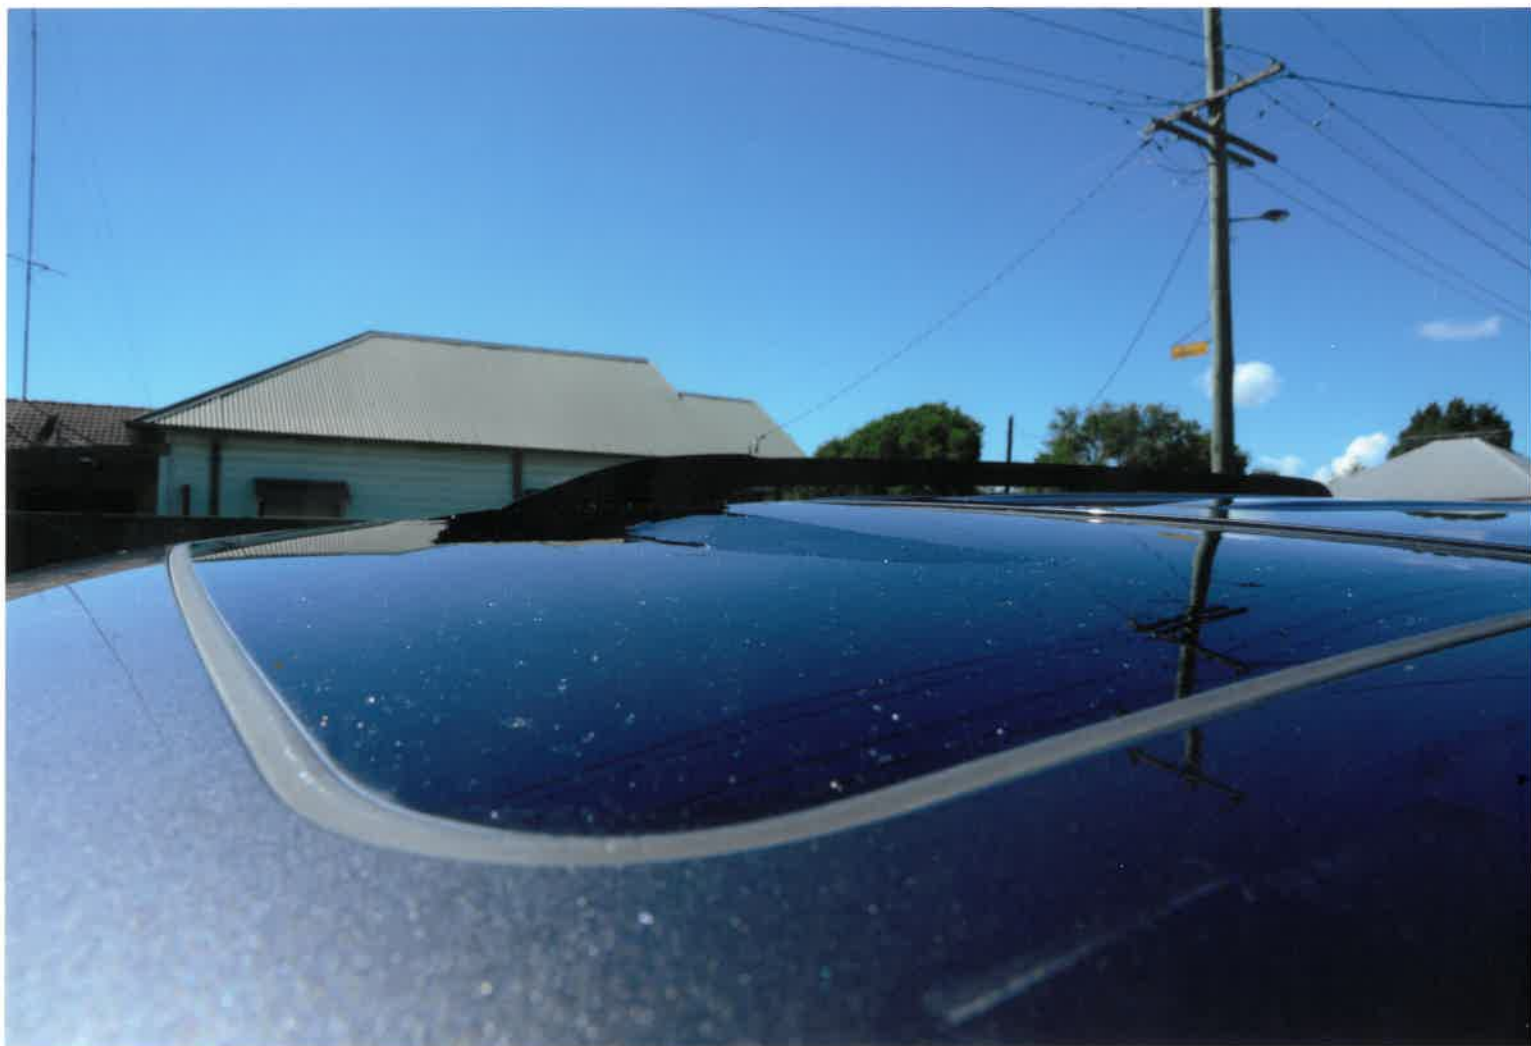
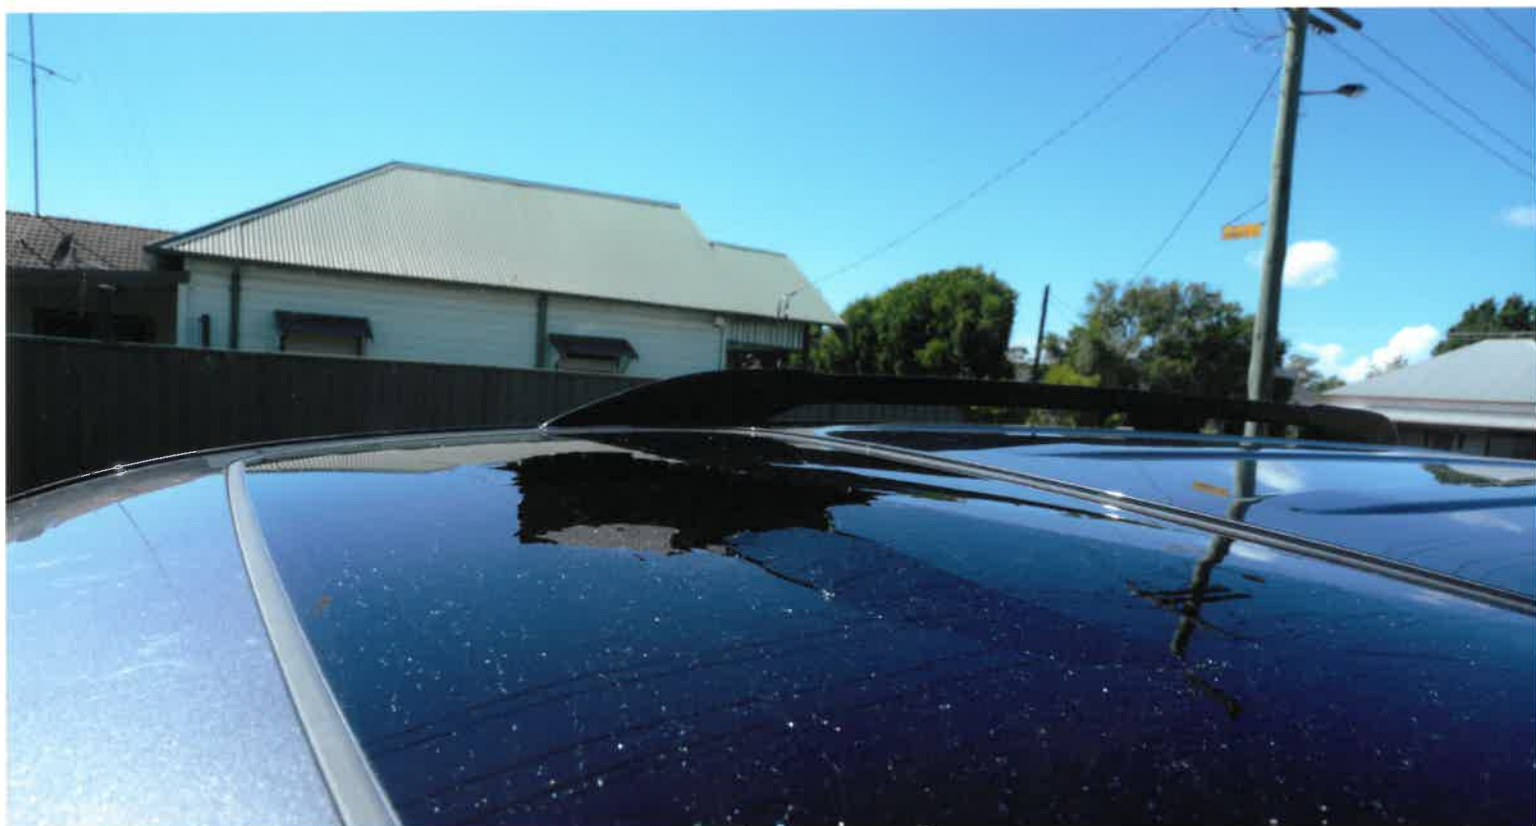
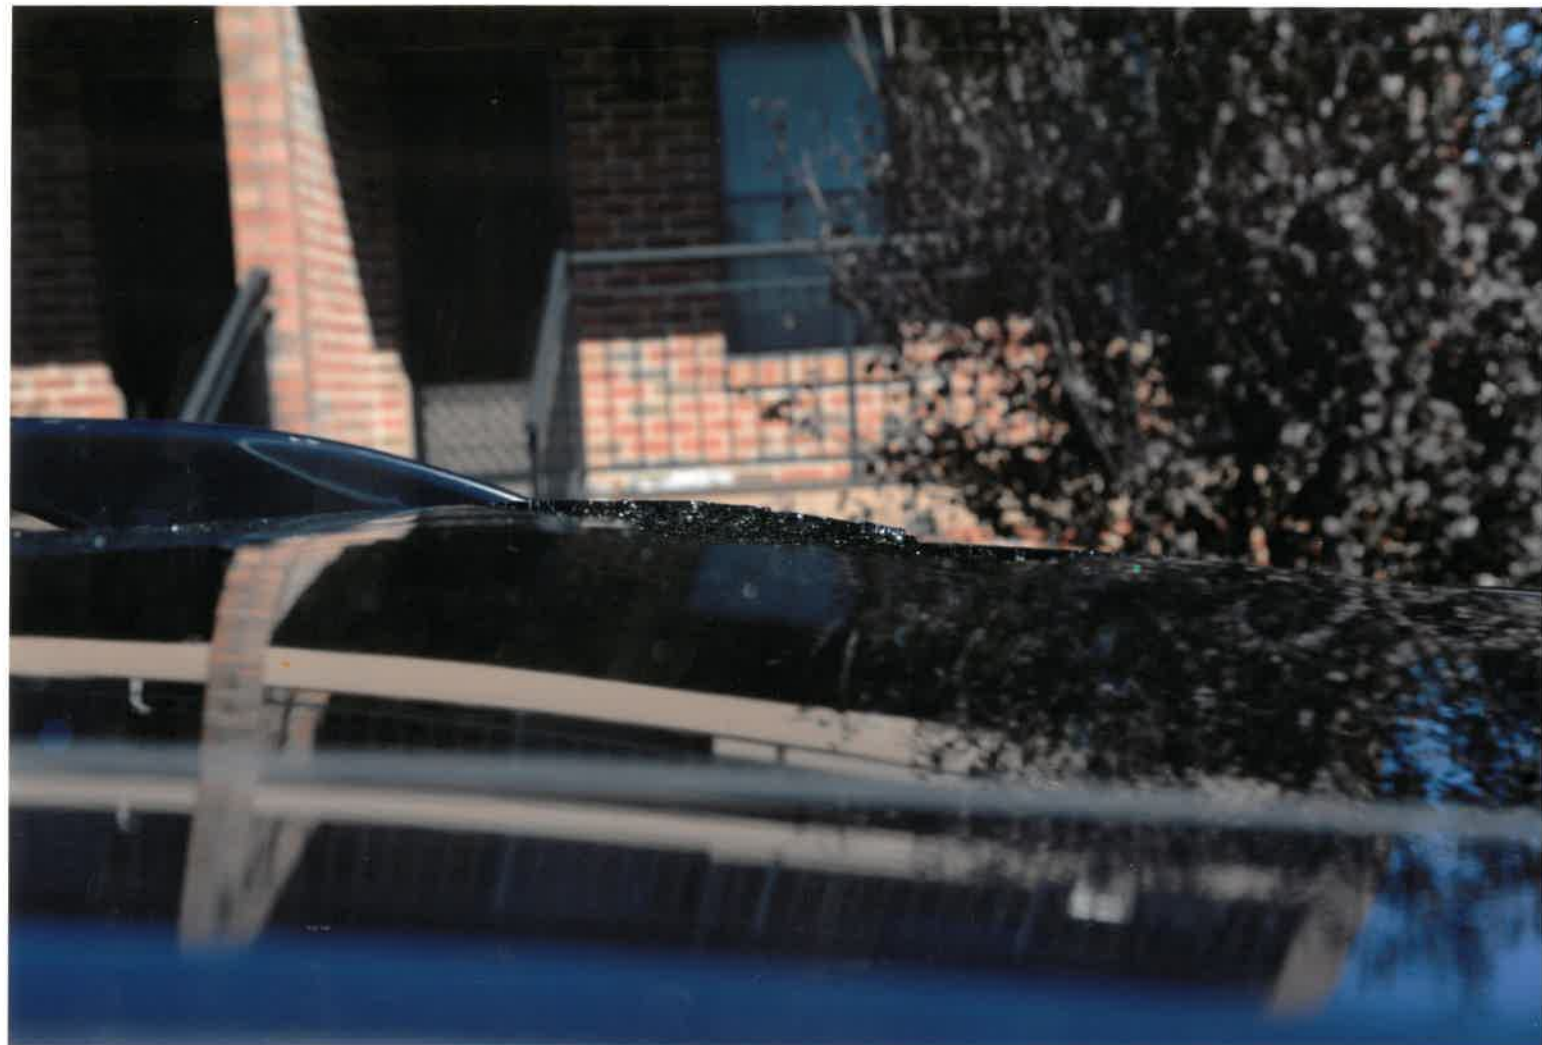
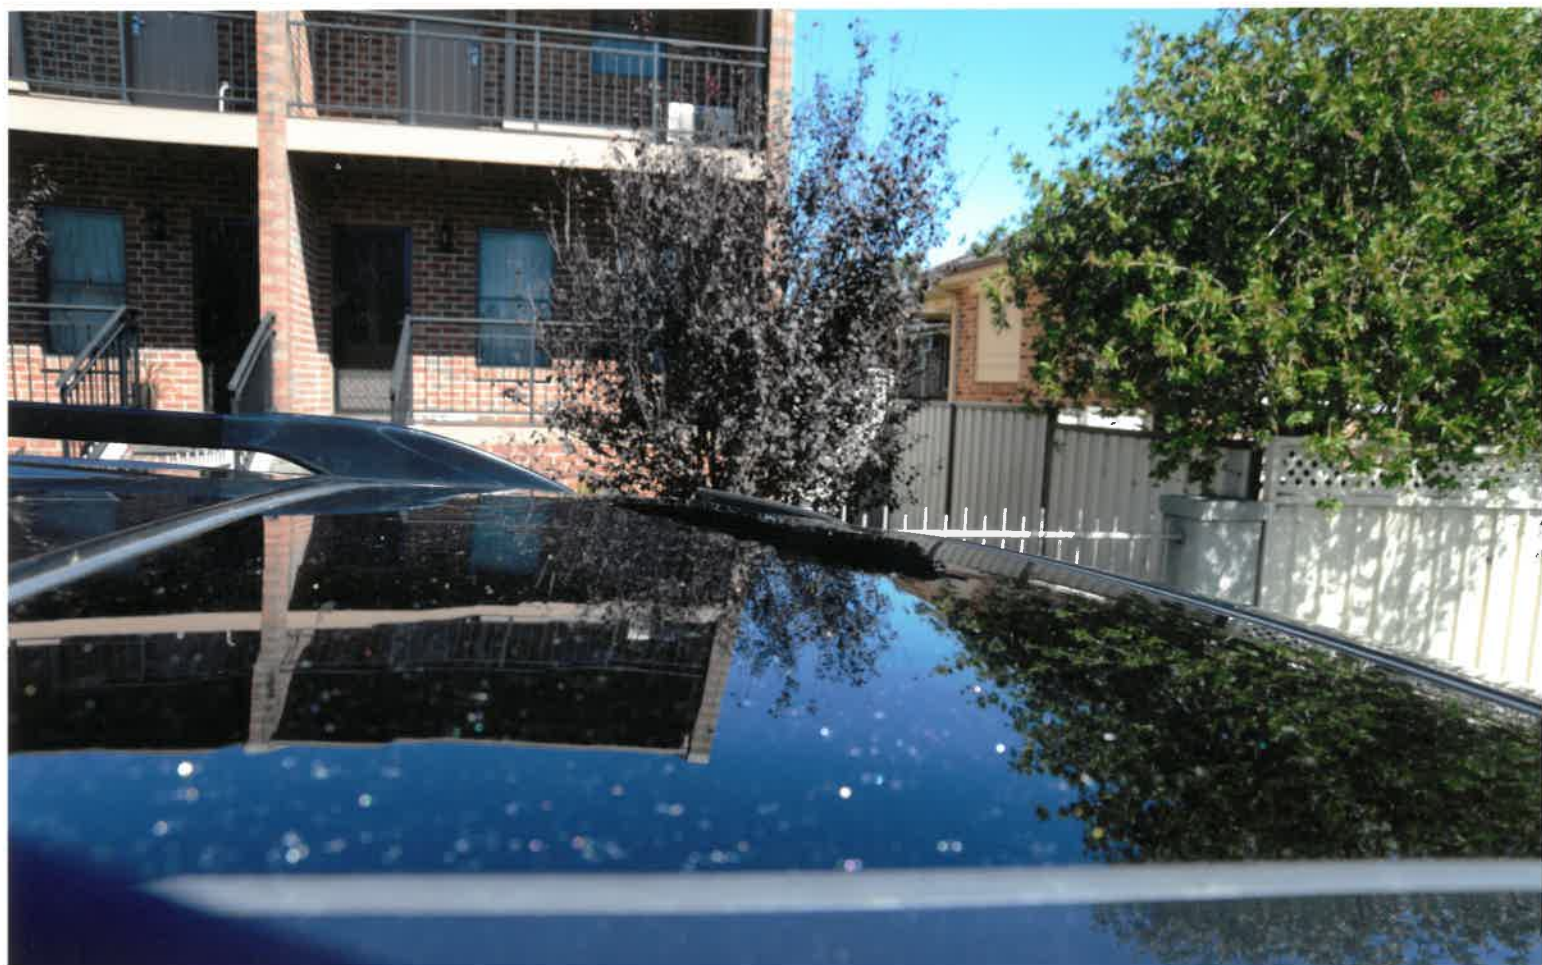
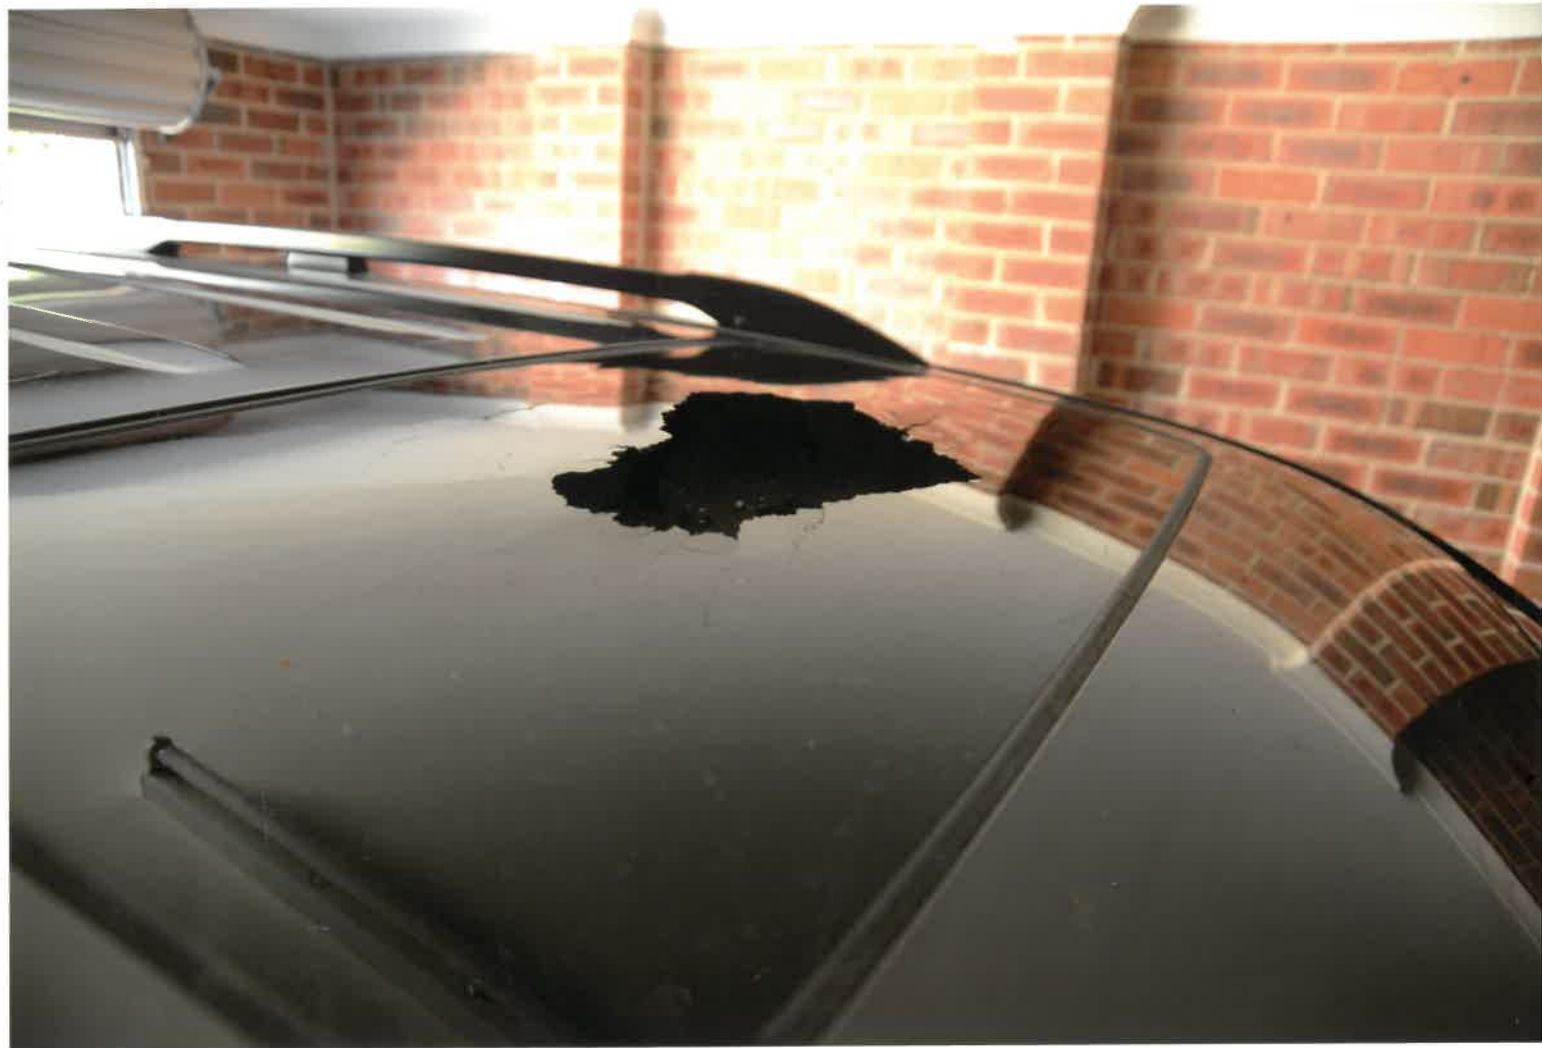
On Sunday the 17th of February 2013, at approximately 1:05pm, I was driving my 2012 Toyota Landcruiser Prado along the s. 22(1)(a)(ii) near the town of s. 22(1)(when I suddenly heard a loud noise. The sound was the deep 'boom' of an explosion, rather than a 'crack' or shattering sound. I soon realised it was the sunroof/moonroof above me that had blown out. At the time I had the internal sun cover closed, which actually acted as a shield against the extensively shattered glass. Without this cover, I would have been covered in minute shards and slivers of glass and no doubt seriously injured. Upon inspection I saw that the moonroof glass exploded up and outward, with the remaining glass angled upward.

I am including photographs of the damage to my vehicle with this correspondence, and it is clearly evident in the photographs that the vehicle's moonroof exploded upward and outward. In addition to these photographs, my vehicle is available for inspection by your department, with it being in the same condition it was in at the time of the incident as it is being stored and not driven. My vehicle is approximately 9 months old with about 18,000 kilometres travelled.
