Incident Report

Incident Number: INC-2017-08-00204

2017 Tesla Model X - doors ripped off from truck passing by

Subject: Investigation into Tesla driver's door opening unintentionally**Summary**

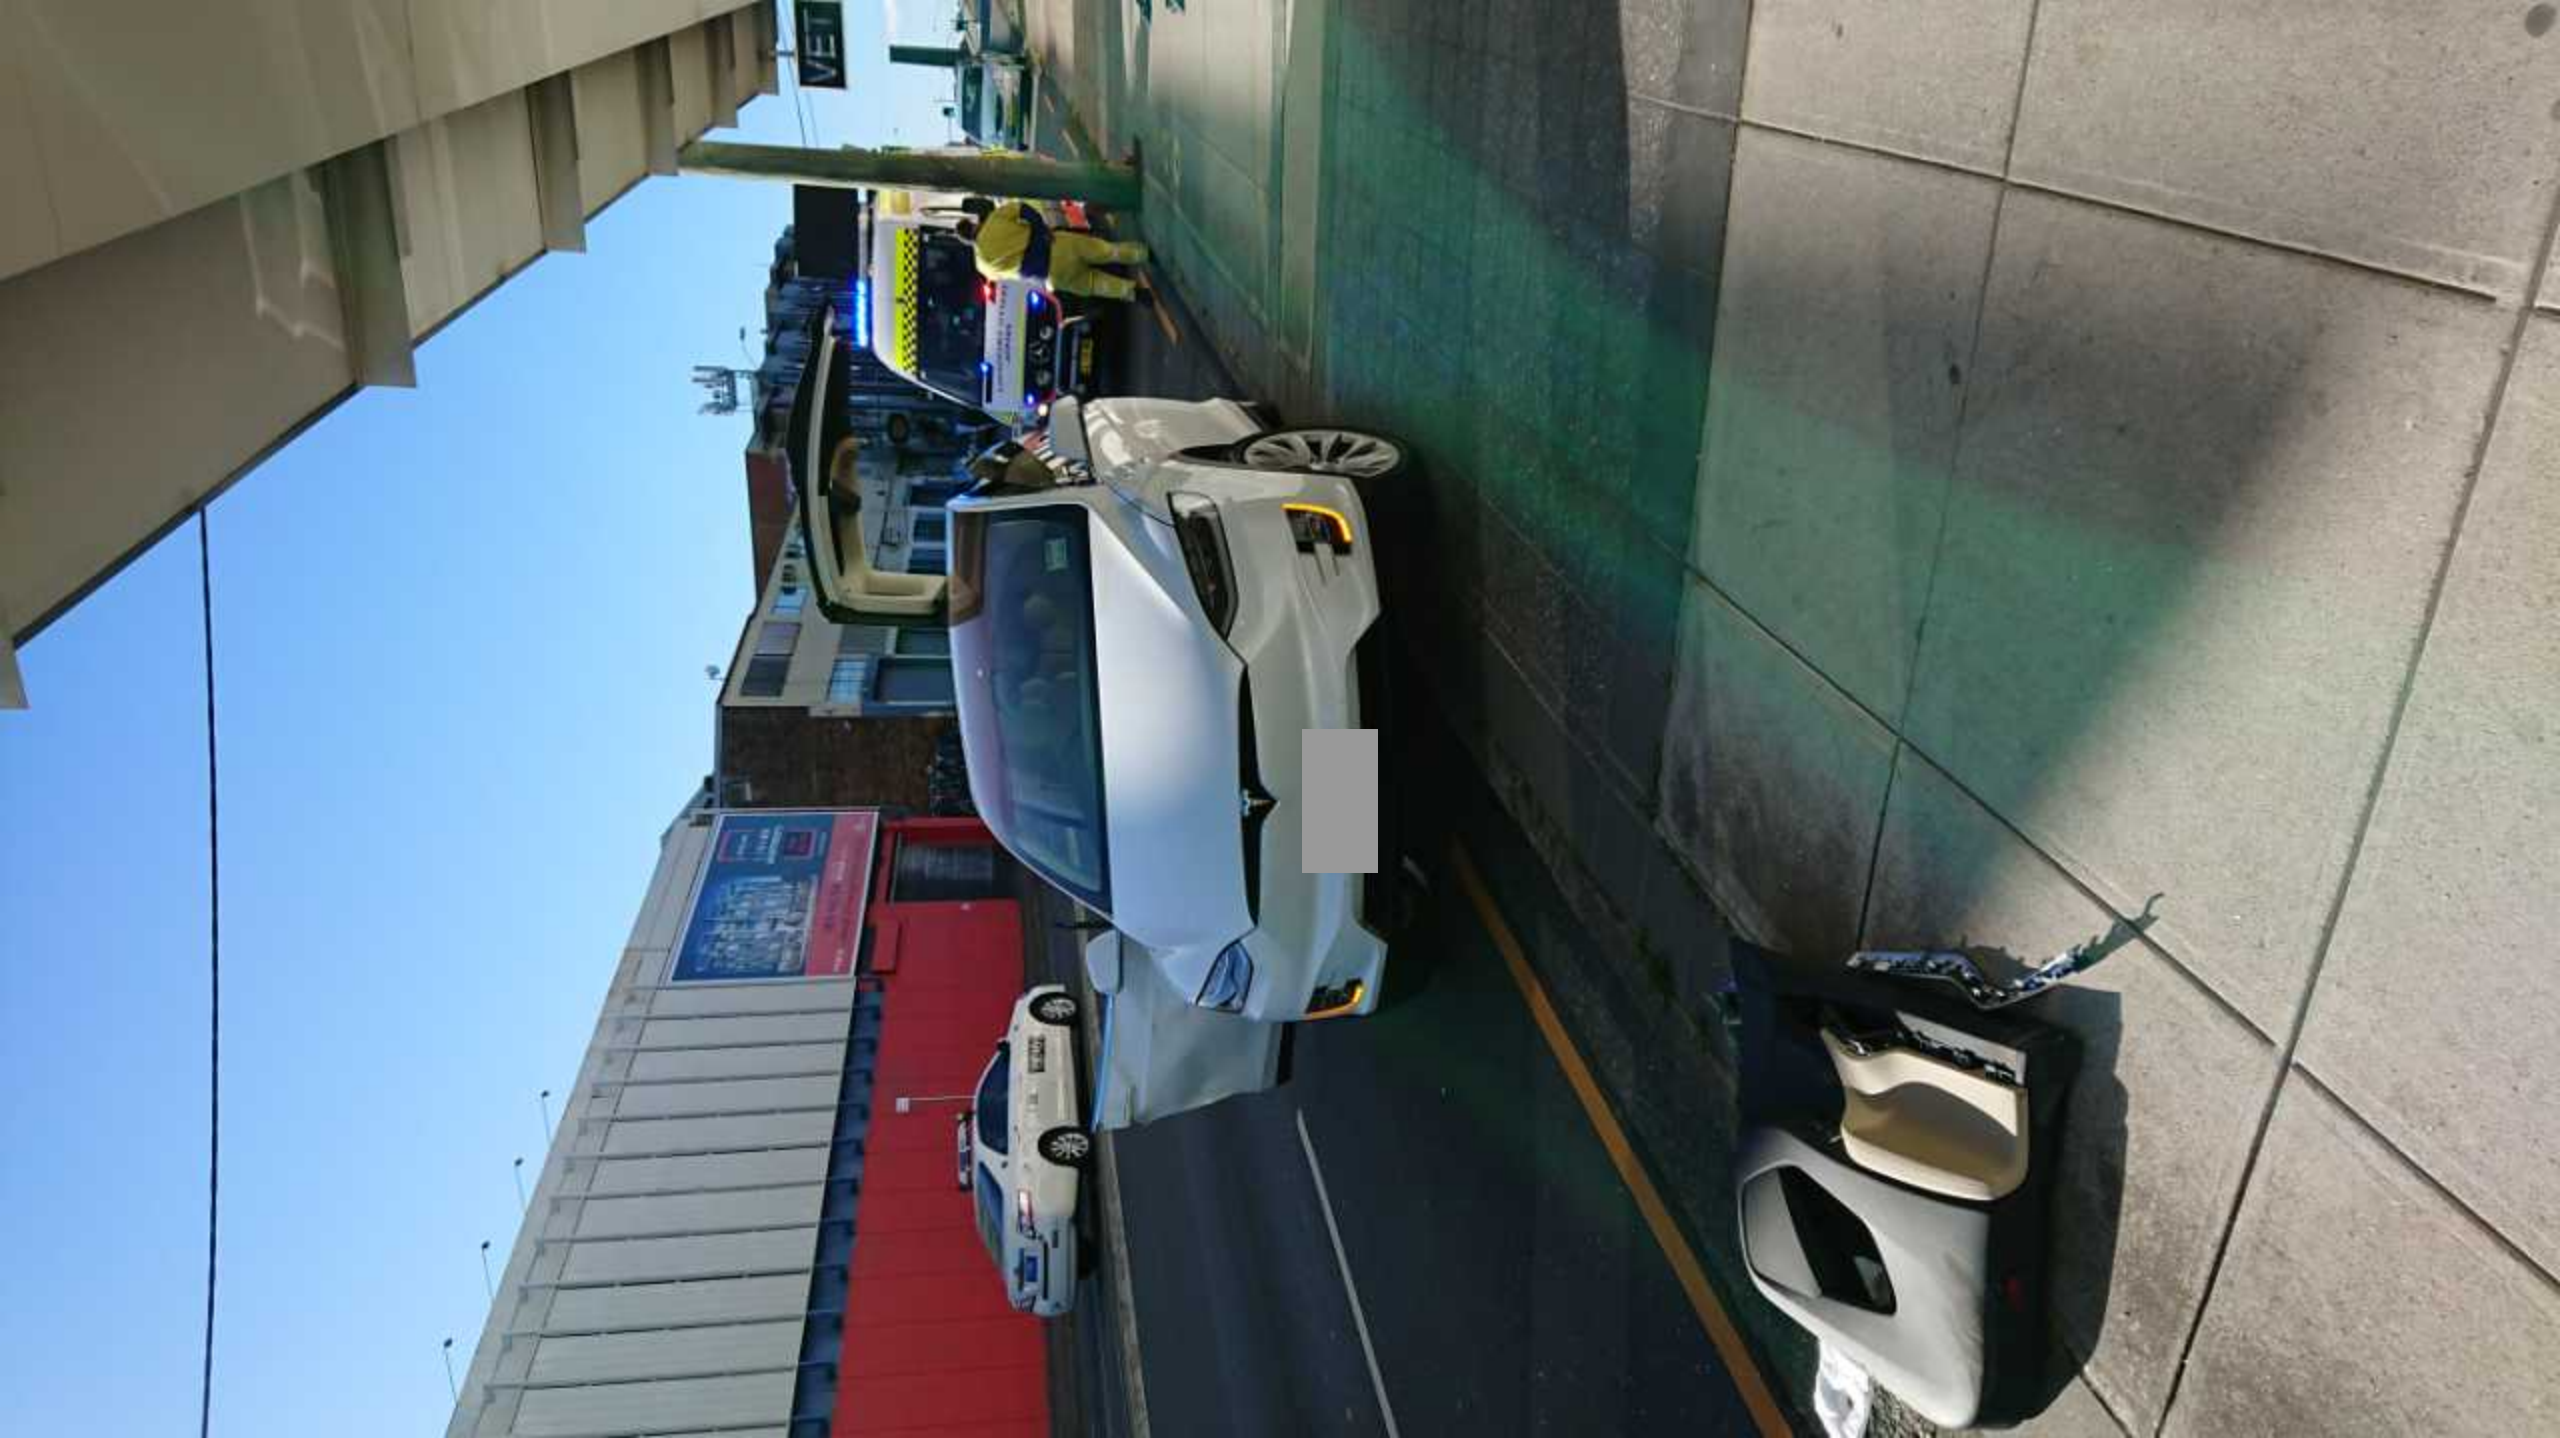
Attachment Title:	DSCPDC_0001_BURST 20170726145605413_COVER.JPG	File Name:	DSCPDC_0001_BURST20170726145605413_COVER.JPG
Attachment Type:		File Size:	1332 KB
		Description:

[REDACTED] claims his vehicle was parked on the [REDACTED] and locked. He was in his office over 25 metres away when the vehicle unlocked itself and both front doors opened. The driver's door opened into a passing truck causing serious damage to the Tesla.

Tesla was contacted and offered to repair the vehicle free of charge, he rejected this offer but wishes for them to buy the vehicle back. Tesla has rejected the suggestion that an issue exists, [REDACTED] and I suggest contact be made with Tesla and an explanation of the issue sought.
